CONDITION MONITORING OF ROLLING ELEMENT BEARINGS IN A GEARED ROTOR

A Thesis Submitted

DEPARTMENT OF MECHANICAL ENGINEERING
INDIAN INSTITUTE OF TECHNOLOGY KANPUR
JANUARY, 1993

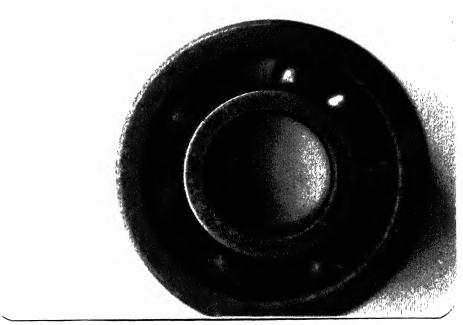
FIG 3.5 CASE B

- [A] All bearings healthy.
- [8] Bearing 1 with broken cage, worn out races and two balls free.
- [C] Bearing 1 with a damaged ball.
- [D] Bearing 1 with excessive play between inner and outer races.

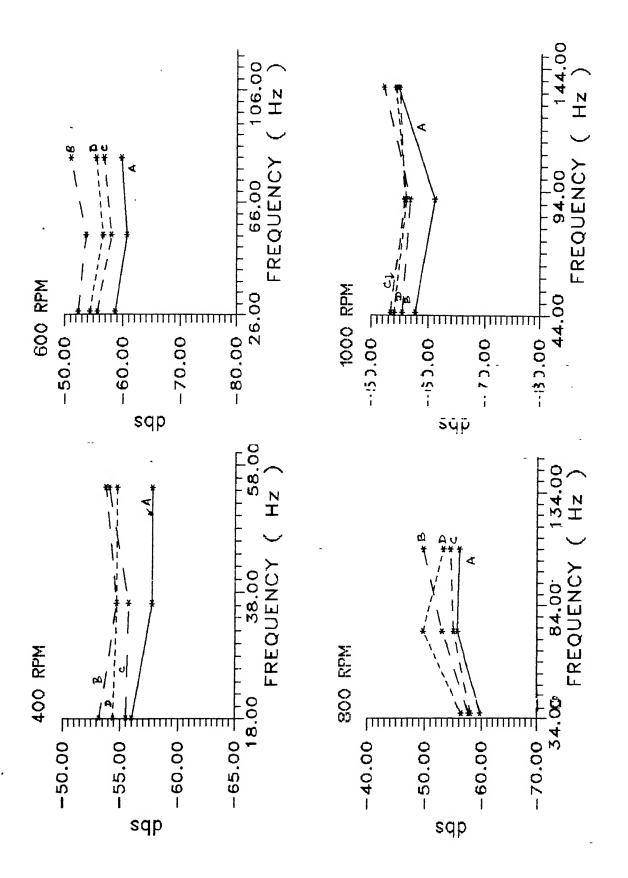
Fig 3.13 AMPLITUDE LEVELS AT IMPACT RATES (FOR OUTER RACE)

also plotted in Figs 3.13-3.14. The rise in the amplitude levels is dependent upon the gravity of fault.

For case B, where fault is very complex (cage broken , two balls free & play between races), the rise in vibration level is more as compared to case C, where only one ball is damaged. (fig 3.13). However, this rise is less in case D (excessive play between inner and outer races). For cases B & D, almost uniform rise in vibration levels can be observed at impact rates for outer race, inner race & balls; For case C, the increase in vibration level is more for impact rates related to balls than for races. This can be explained by the fact that, for cases B & D, all three components are faulty whereas for case C only one ball is damaged.

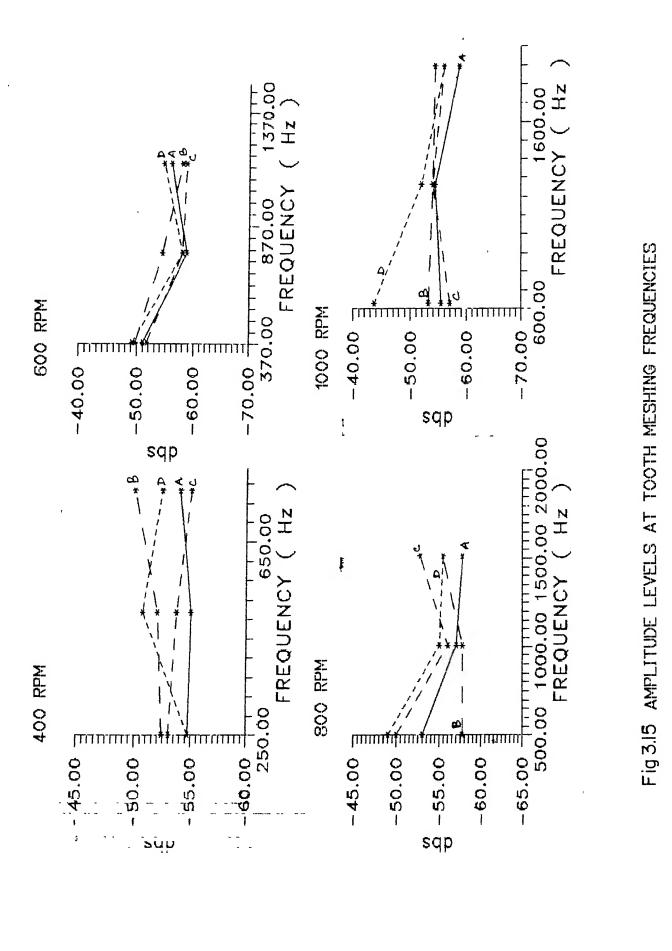
Fig 3.15 AMPLITUDE LEVELS AT TOOTH MESHING FREQUENCIES

Table 3.2 gives the amplitude levels at tooth meshing frequencies for all four cases, at all rotational speeds. For case C rise in vibration level is less then cases B & D where faults are more grave. Fig 3.15 contain plots for all the four cases for comparison. As can be seen, plot for case C lies below plots for cases B & D.
